Technical Analysis Upper Alewife Brook Basin Impact Study

February 29, 2012

Upper Alewife Brook Watershed
Technical Analysis

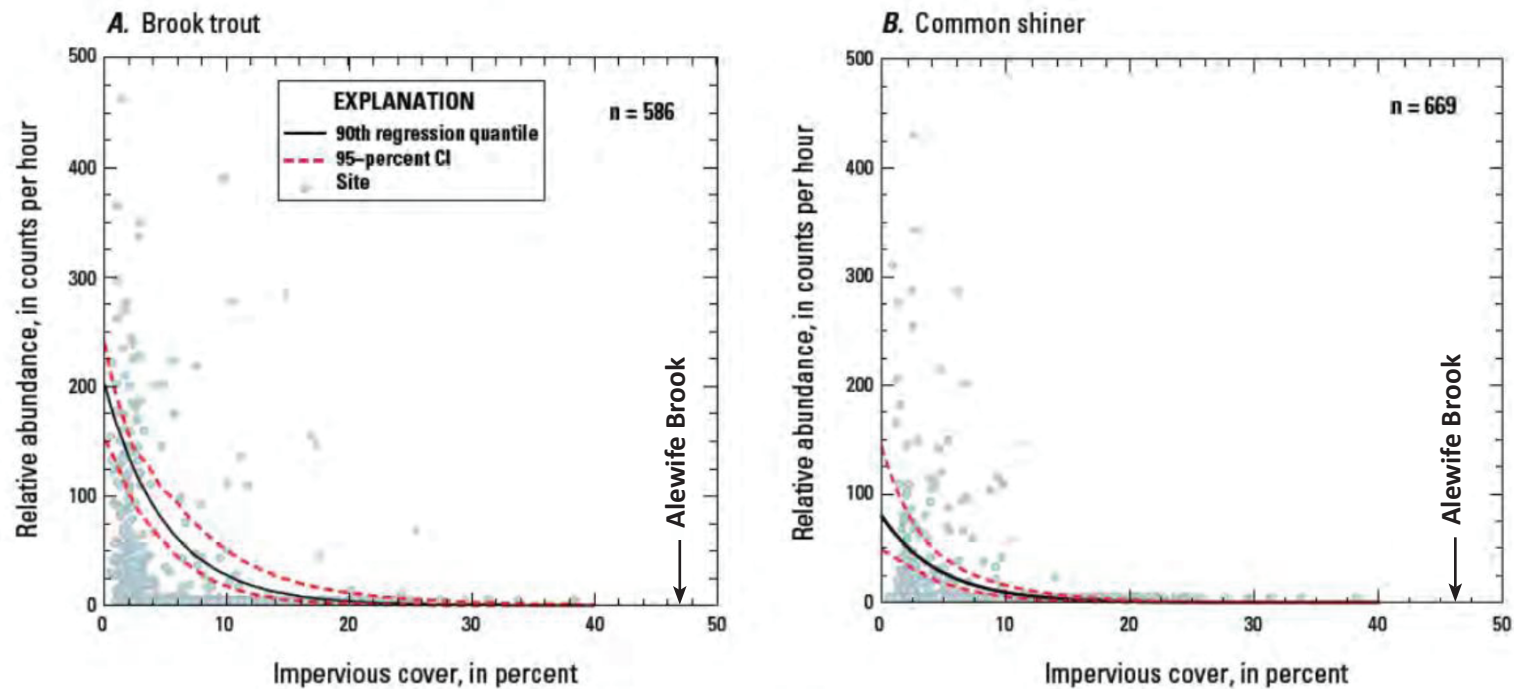
Figure 5 – Quantile regression relations between relative abundance of A, brook trout and B, common shiner and percent impervious cover for the contributing areas to selected fish-sampling sites on Massachusetts streams. CI, confidence interval; n, number of sites. Fish samples were collected from 1998 to 2008.

According to a recent publication by the USGS and the Commonwealth of Massachusetts that examined the relationship between impervious area and the health of fish communities as an indicator of ecosystem health, watersheds with impervious cover as low as 5% show significant ecological impacts. Figure 5 shows the relationship between impervious cover and native fish species (Armstrong et al, 2011).
